Seismic rehabilitation of reinforced concrete beam-column connections by FRP material

A.I. Karabinis¹, T.C. Rousakis¹

Summary

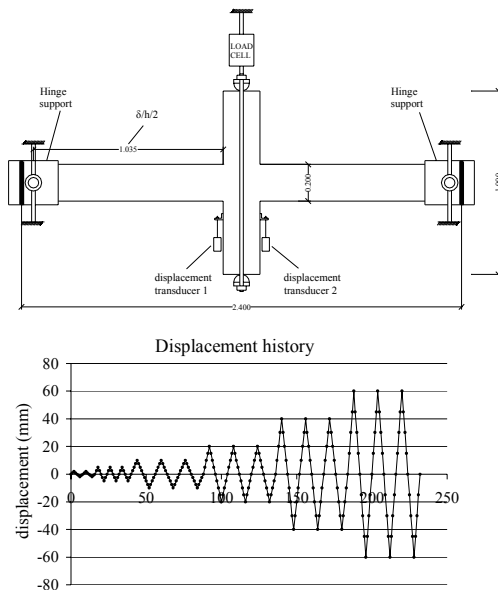
Figure 2. Testing scheme and displacement steps.

The initial specimens were subjected to cycles of increasing displacement steps, imposed by loading axially the beams of the connection according to the testing arrangement in figure 2. Two displacement transducers (DTs) were placed from both sides of the connection to measure its vertical displacement. The displacement steps were successively increased according to figure 2. The corresponding maximum relative storey drift was 5.3%. In this paper, due to limited space, the behaviour of specimens R50B2 and R100B2 is further discussed.

The evaluation of the presented repairing technique effectiveness was conducted by subjecting the rehabilitated specimens to the same displacement history with the initial specimens (fig. 2).

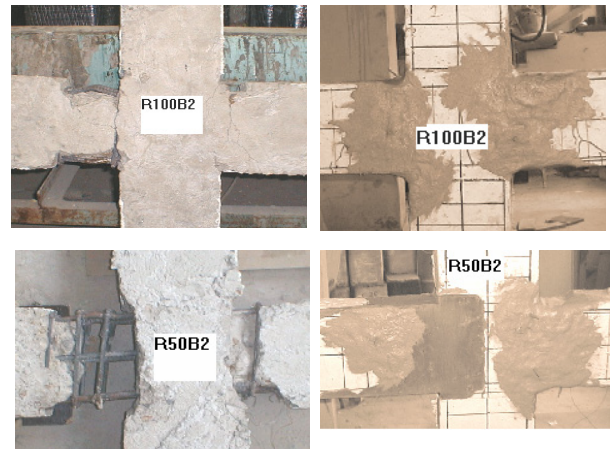
Figure 3. Specimens before and after rehabilitation

After initial testing the rehabilitation procedure followed, with special treatment of damaged specimens. The disintegrated concrete core was removed. Main reinforcement was straightened eliminating local buckling. In the case of extensive disintegration of concrete core (left side of R50B2), high-strength concrete (HSC) of EMACO S55 [6] type was cast to substitute the concrete core (case 1 in the middle of table 1). In the case of minor or capillary cracks as well as spalling of concrete, an epoxy paste of P103 S&P type was used while the cracks were filled with an injectable resin of J12 S&P type (case 2 in the middle of table 1). The succeeded corner radius of the rectangular cross-section of the specimens was around 10 mm. Repaired specimens are presented in figure 3.

Extensive damage of the tested BC joints was caused from both sides of the joint in the critical zone (left side of fig. 3). In specimen R50B2, severe cracking of concrete core led to complete disintegration near the joint. Specimen R100B2 presented spalling of concrete cover and minor cracking. Yielding of longitudinal reinforcement was evidenced in all specimens, while minor local buckling of main reinforcement took place in specimen R100B2 with 100 mm spacing of stirrups during endmost displacement steps. The localization of damage was not related to the side that included the lap splice of bars. Load – displacement behaviour of as built specimens is discussed in relation to repaired specimens.
